CULTURAL RESOURCES REPORT

Waldo Canyon Fire

Incident # CO-PSF-0000728

TECHNICAL SPECIALIST REPORT – BURNED AREA EMERGENCY RESPONSE

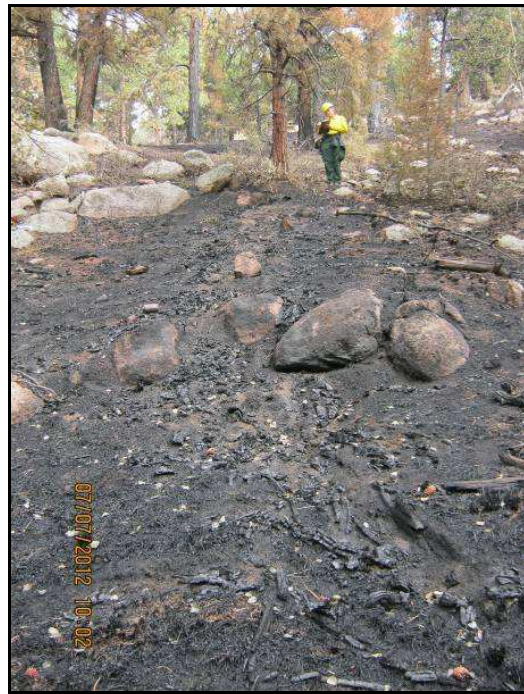
The data recovered during the field inspections identified one cultural resource as immediately threatened. Site 5EP6847 (a Class I site) has its values at risk due to water flow/erosion in two drainages that hold artifact concentrations. Although the site had its wooden features burnt in the fire, the site's cultural value lies in its potential to yield more information important in history (NRHP Criterion D). Analysis of the soils at the artifact concentrations burnt over identified a water repellency of 2 inches depth. The water-repelling action of the burnt soils in combination with the slope wash and the lack of vegetation may cause the loss of this information potential and puts the site's value at risk.

The site had been determined officially eligible to the national register of historic Places due to its potential to yield more information important in history (Criterion D). Three artifact concentration features of the site were found to be at risk of being displaced due to erosion or looted. This could result in the loss of important scientific information.

*Site 5EP6847, artifact concentration 4, erosion and burn damage, view NW
(Photo: 1126 606 07/07/2012)*

Cover artifact concentrations at risk with wood straw

Aerial mulching with wood shred would be applied to the southern half of the site, in order to ensure ground cover of the artifact concentration areas.

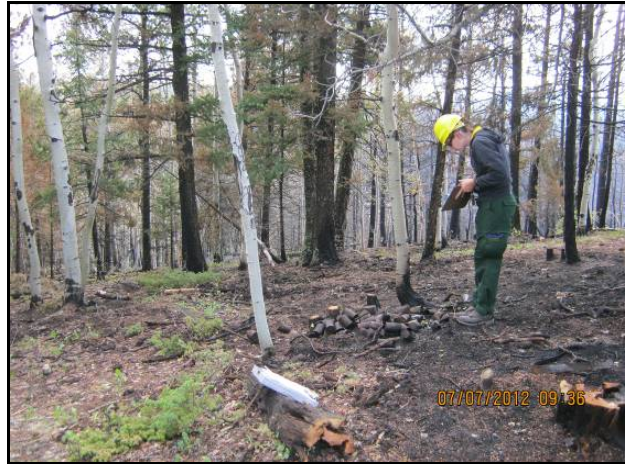
Another concern for site 5EP6847 is looting, since the vegetation that once hid much of these artifact concentrations is now gone and given that the site is located on the edge of a system road, with artifacts visible from the roadbed itself. Mitigative treatment at this site would need to take place in order to protect the cultural resource values at risk. Cultural Resource sites are a non-renewable resource. If no action is taken to protect the sites, valuable historical and scientific information could be lost.

Site 5EP6847, overview of new artifact concentration exposed by fire, view E (frame A126-603, 07/07/2012)

Mulch provides immediate ground cover and helps reduce surface erosion as well as hides the artifacts from view. This treatment provides protection to heritage sites from erosion and looting. Monitoring will dictate whether additional treatments are necessary.

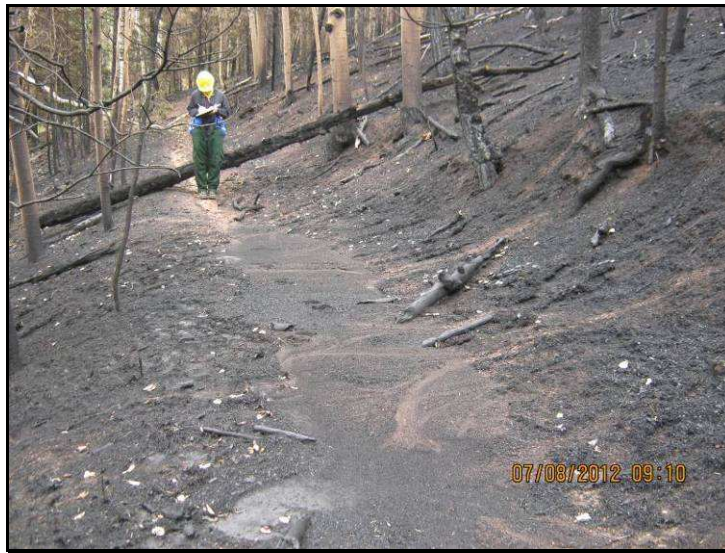
The BAER team also identified one additional site (**temp#RHT-03: Class II**) already being affected by post-fire erosion effects. Although this historic trail is not at risk of being lost, two spots uphill from this trail could benefit from manually spreading weed-free straw mulch along the hill slope. One area measures about 150 feet uphill x 40 feet wide. The other area should cover at least 200 feet uphill x 100 feet width along a draw. Both areas of concern were flagged in the field. Small hand dug water bars and dips, as well as small hand trenches, could also help divert water from the trail in areas where water could flow along the path of the trail due to the slope. Because this trail is of interest to the public for recreational use (i.e. under special use permit), partners might be interested in implementing these trail protection measures.

*Site temp#RHT-03, view54°, hill slope erosion onto trail
(frame A127-633, 07/11/2012)*
